## COATINGS FOR LIGHTING PROTECTION OF STRUCTURAL REINFORCED PLASTICS

TECHNICAL REPORT AFML-TR-70-303 Pt. I

March 1971

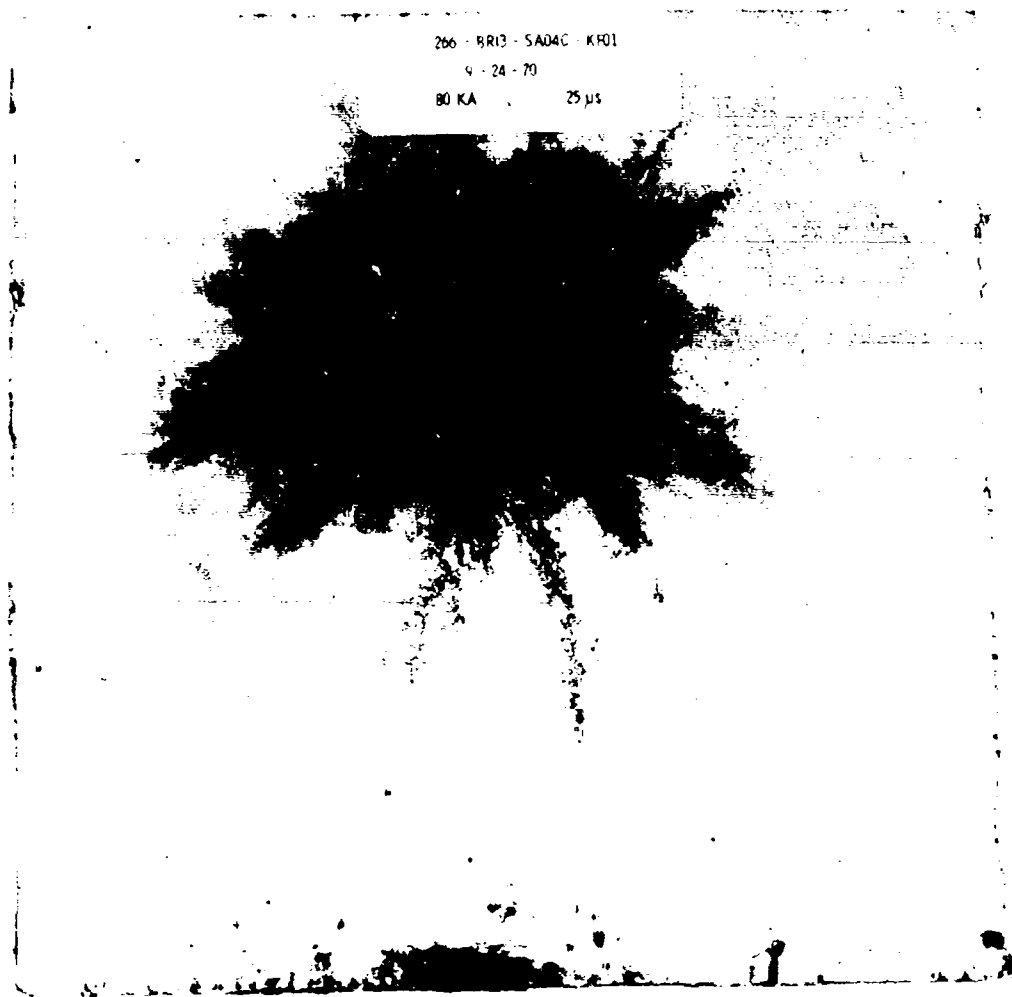
Fig. 81 80 KA DISCHARGE DAMAGE TO SILVER COATED BORON EPOXY LAMINATE

The coating did not protect the boron composite from an 80 KA discharge. A 1 by 5-inch piece of the outer ply was destroyed and some resin scorching in the remaining plies was observed (Figure 81). The lesser degree of discoloration of the surface indicates the fibers carried a large amount of the discharge. In addition, the coating was burned at the ground attachment. This is due to arcing from the fibers to the ground attachment. At the 120 KA discharge level, the panel was punctured and a sizable area of boron was delaminated. Blistering at the ground attachment was also observed (Figure 82).

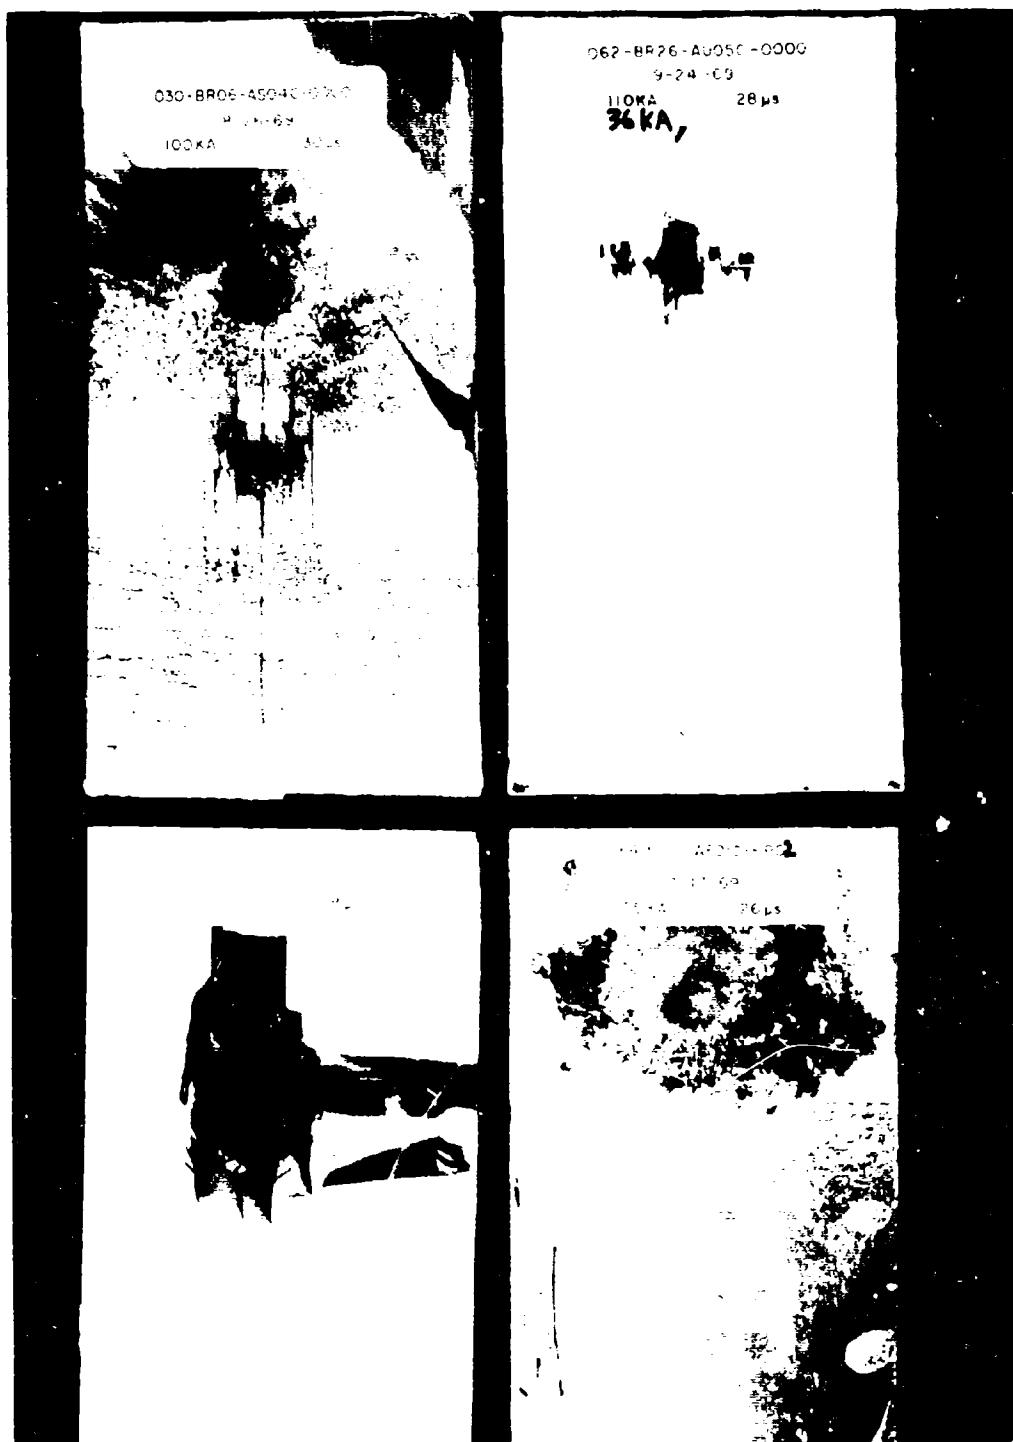
Figure A-16

The substrate was severely damaged.
